NASA Contractor Report 166002

Flight Service Evaluation of Composite Components on the Bell Helicopter Model 206L: Design, Fabrication, and Testing

**Bell Helicopter Textron Inc.
Fort Worth, Texas**

**Contract NAS1-15279
November 1982**

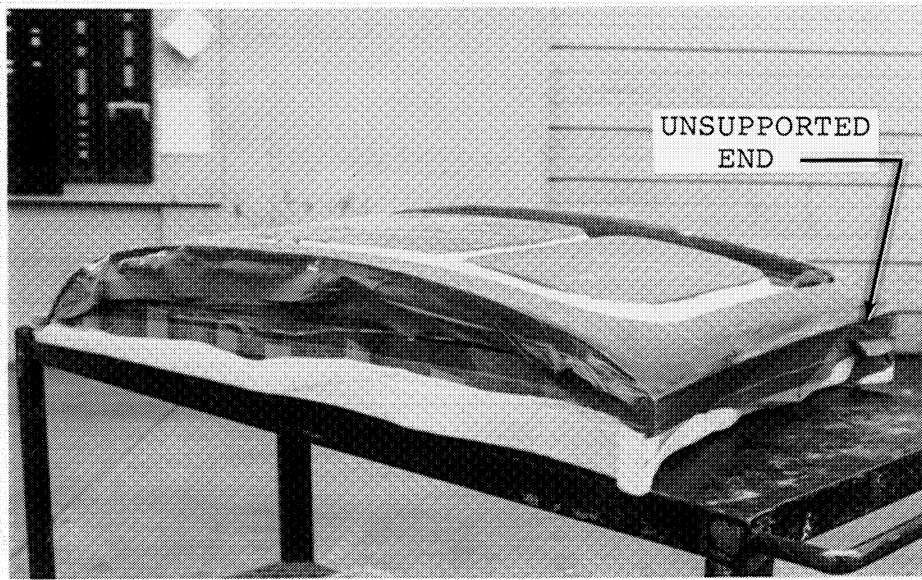
a. View of door half in fixture.

Figure 15. Litter door bow caused by flexibility of fixture.

It was necessary to remove the plexiglass window before the door was straightened because of the large difference in thermal expansion between the plexiglass and the Kevlar/epoxy. After the straightening process, the window was replaced.

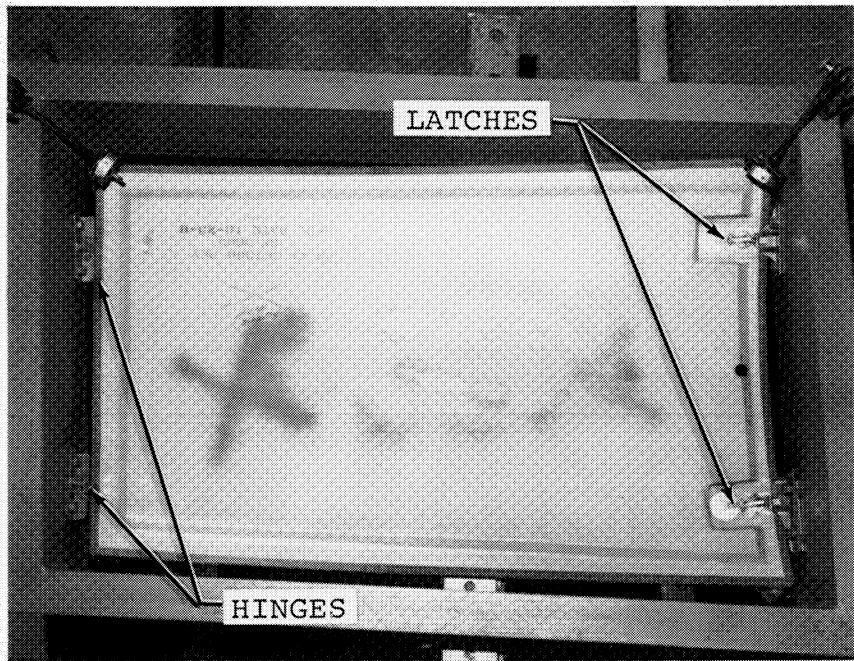
2. T. + S. a. Test setup

For the pressure test, the door was tested in the fixture shown in Figure 22a. The door was attached to the jig by two hinges and latches. Pressure was applied by means of water bags. Failure occurred at 0.794 psi, or a total of 695 pounds in the metal hinges, as shown in Figure 22b. This is technically a margin of safety of 13.4 percent, but is based on a metallic hinge failure, not a failure of the composite material.

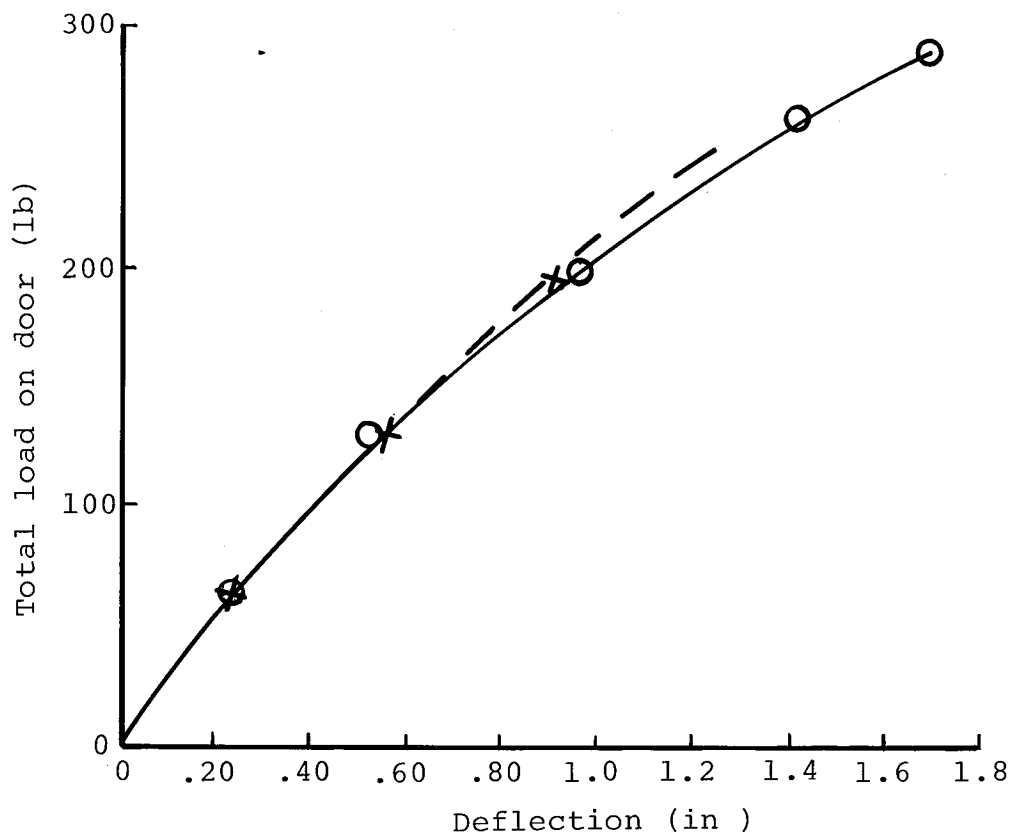
Figure 23. Deflection of geometric center of two baggage doors under test load.

The load-deflection curves of the geometric center of two doors are shown in Figure 23. The curves are nonlinear, so it would appear that there would be a significant permanent set when the load was removed. In the test represented by the x's and dotted lines, the load was removed after 192 pounds had been applied. Despite the nonlinearity of the load-deflection curve, the permanent set was a negligible 0.018 inches.

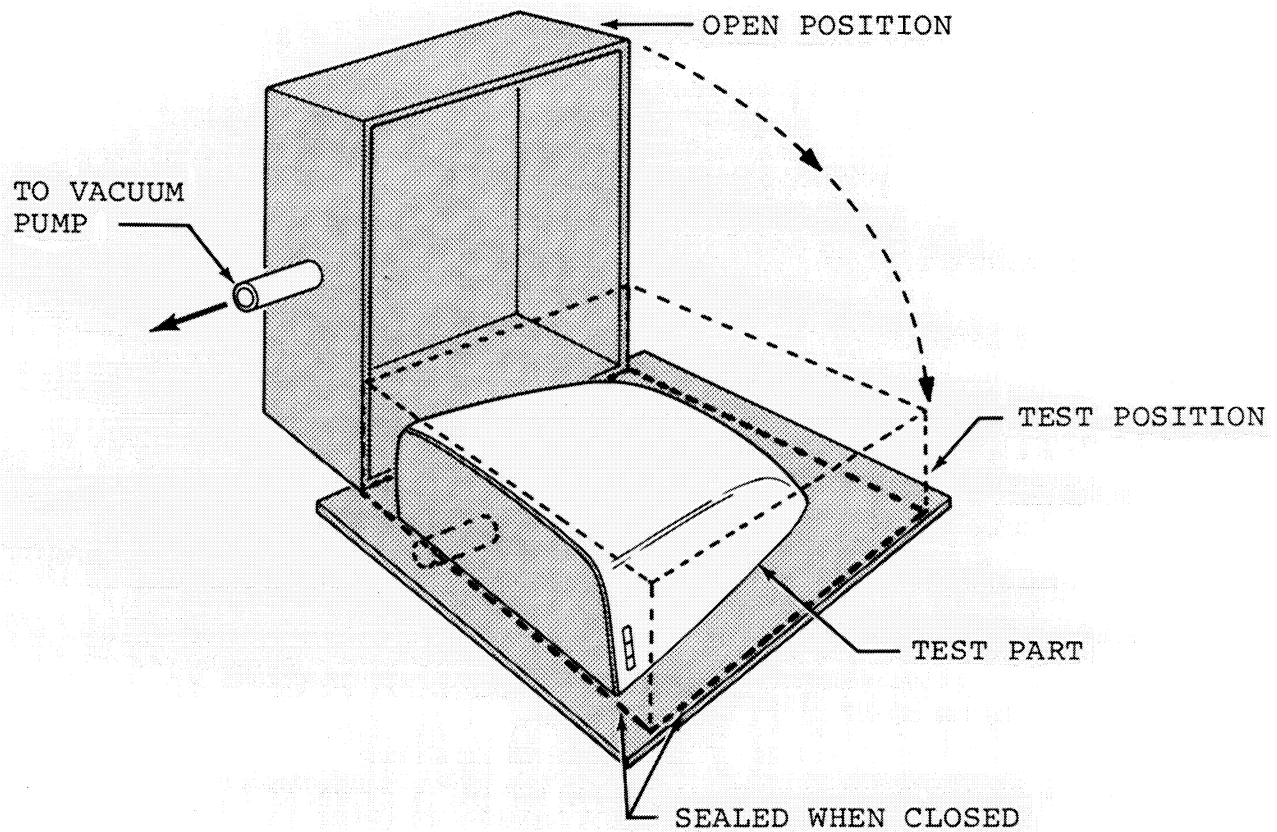
Figure 26. Pressure test setup on forward fairing.

Figure 26 shows the test setup for the fairing. The fairing was attached to the test fixture at the forward hinge points and aft latches. The cover was closed and sealed. Air was then evacuated from the jig, causing a vacuum on the outer surface of the fairing. Air was evacuated until failure occurred.

Two fairings were tested to failure. The first one failed at 1.51 psi at the inner corner splice, as shown in Figure 27. The second fairing failed at 1.94 psi, but was not a composite failure. At 1.94 psi the right-hand aft latch slipped, causing some local, noncatastrophic failures of the surrounding structure.

Subsequent examination of the test parts revealed a possible knife cut in the failed area of the first specimen and the probability of a faulty latch on the second specimen. (The much higher load that five subsequent fairings withstood supports this theory. This is discussed in Section 6.2.6).
